# Reaction Control System Thruster Cracking Consultation: NASA Engineering and Safety Center (NESC) Materials Super Problem Resolution Team (SPRT) Findings

Rebecca A. MacKay  
Glenn Research Center, Cleveland, Ohio

The shuttle orbiter's reaction control system (RCS) primary thruster serial number (S/N) 120 was found to contain cracks in the counter bores and relief radius after a chamber repair and rejuvenation was performed in April 2004. Relief radius cracking had been observed in the 1970s and 1980s in seven thrusters prior to flight; however, counter bore cracking had never been seen previously in RCS thrusters. Members of the Materials Super Problem Resolution Team (SPRT) of the NASA Engineering and Safety Center (NESC) conducted a detailed review of the relevant literature and of the documentation from the previous RCS thruster failure analyses of the 1980s. It was concluded from the review that the previous failure analyses lacked sufficient documentation to support the conclusions that stress corrosion cracking or hot-salt cracking was the root cause of the thruster cracking and lacked reliable inspection controls to prevent cracked thrusters from entering the fleet. The

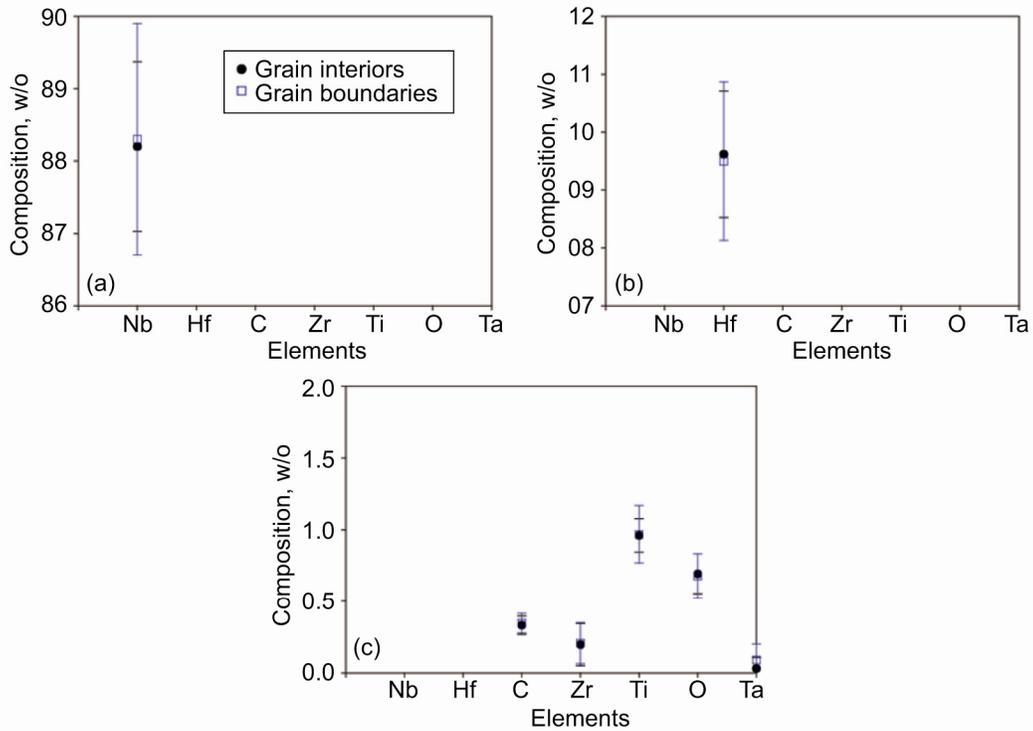
Figure 19.—Composition levels for (a) niobium (Nb), (b) hafnium (Hf), and (c) carbon (C), zirconium (Zr), titanium (Ti), oxygen (O), and tantalum (Ta) in an uncracked region near counter bore of bolt hole K. Filled circles represent data obtained within grain interiors and unfilled squares represent data from grain boundaries. Forty locations are represented by these data, which show no evidence for chemical segregation of the major, minor, and interstitial elements in uncracked C-103.

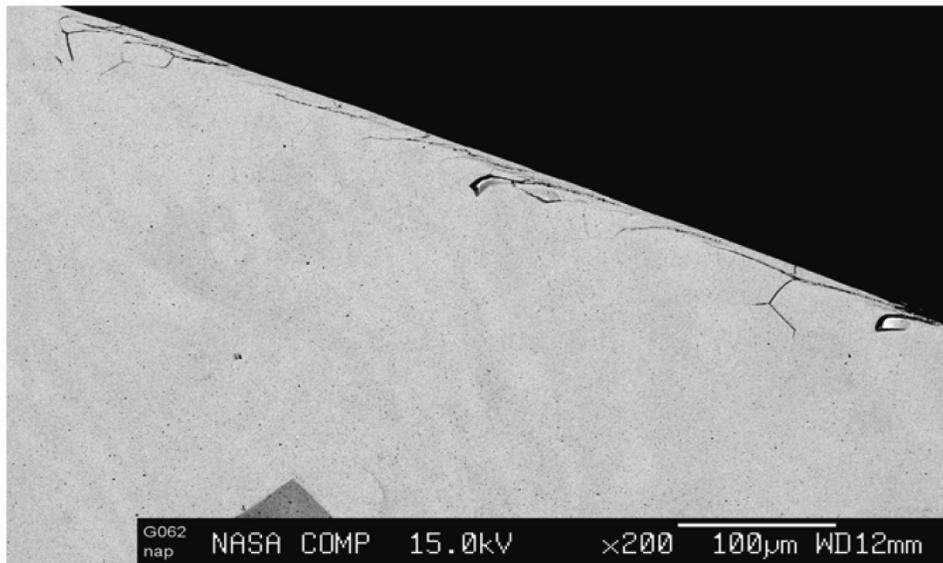
Figure 20.—Backscattered electron image of cracking observed in the 316 °C/207 MPa (600 °F/30 ksi) C-ring test specimen. Cracks are typically up to two grains deep and are also evident running parallel to the surface, beneath the cold-worked region from the machined surface. Specimen supplied by S. Yang at Boeing Rocketdyne.

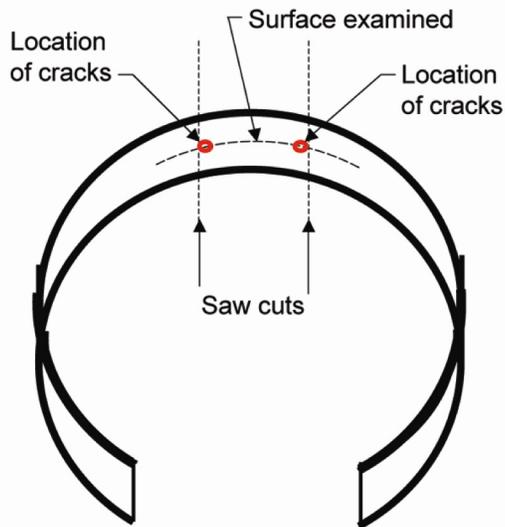
Figure 21.—Schematic illustrating the C-ring test specimen for attempted reproduction of hot-salt cracking. Cracks were examined from section having complete coverage of hot salt and applied stress at the maximum tensile stress. Cracks were consistently located near saw cut ends (within red circles) and were never observed along the tensile surface in the middle of the sample.

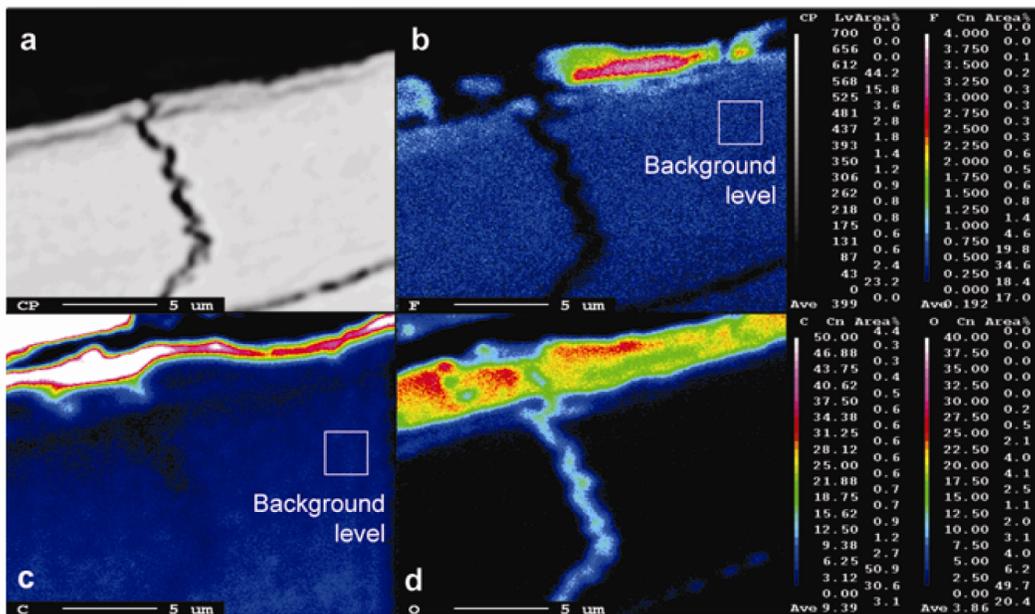
Figure 22.—(a) Backscattered electron image showing surface-connected cracking in 316 °C (600 °F) C-ring test specimen for reproduction of hot-salt cracking. Electron microprobe dot maps shown for (b) fluorine, (c) carbon, and (d) oxygen. Unlike S/N 120, the C-ring test specimen showed no fluorine within the surface-connected cracks.

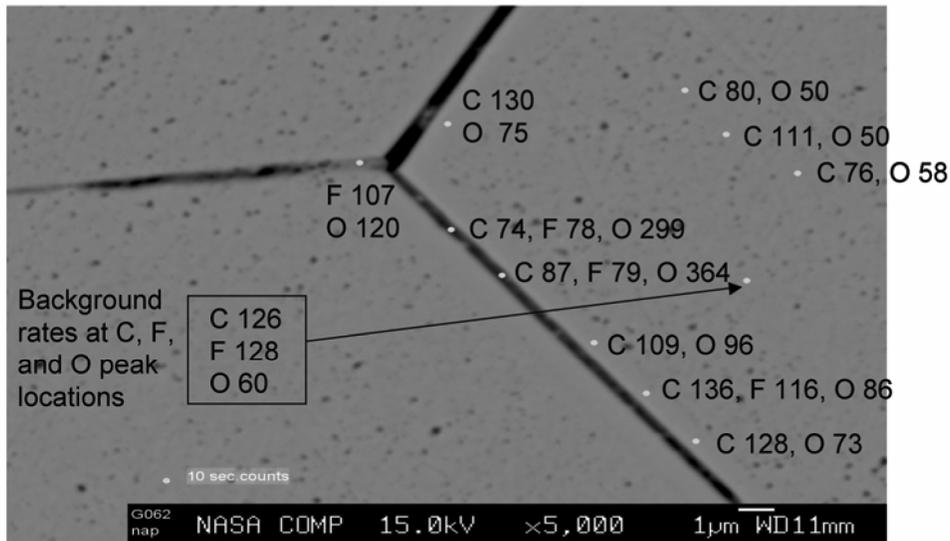
Figure 23.—Electron microprobe count rates from various locations in 316 °C (600 °F) C-ring specimen indicate that higher oxygen (O) levels were present within the cracks. Elevated levels of carbon (C) and fluorine (F) were not found within the cracks when compared to background rates for C and F peak locations. Count rates provided were obtained from a 10-sec analysis for each element at each point in the microstructure.

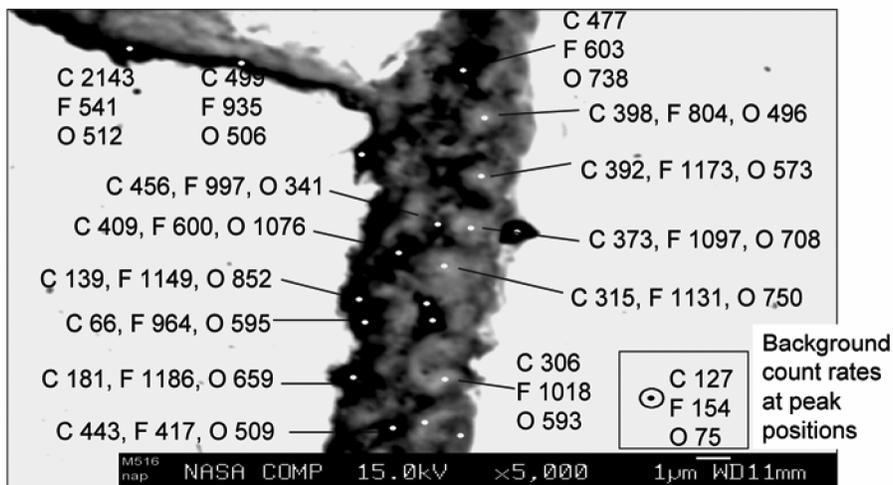
Figure 24.—Electron microprobe count rates are given for carbon (C), fluorine (F), and oxygen (O) for numerous locations within the relief radius crack in S/N 120 near bolt hole J. The C, F, and O rates within the crack are significantly higher than the background count rates at the C, F, and O peaks. Note that the intergranular crack in S/N 120 is significantly wider than that within the 316 °C (600 °F) C-ring specimen.

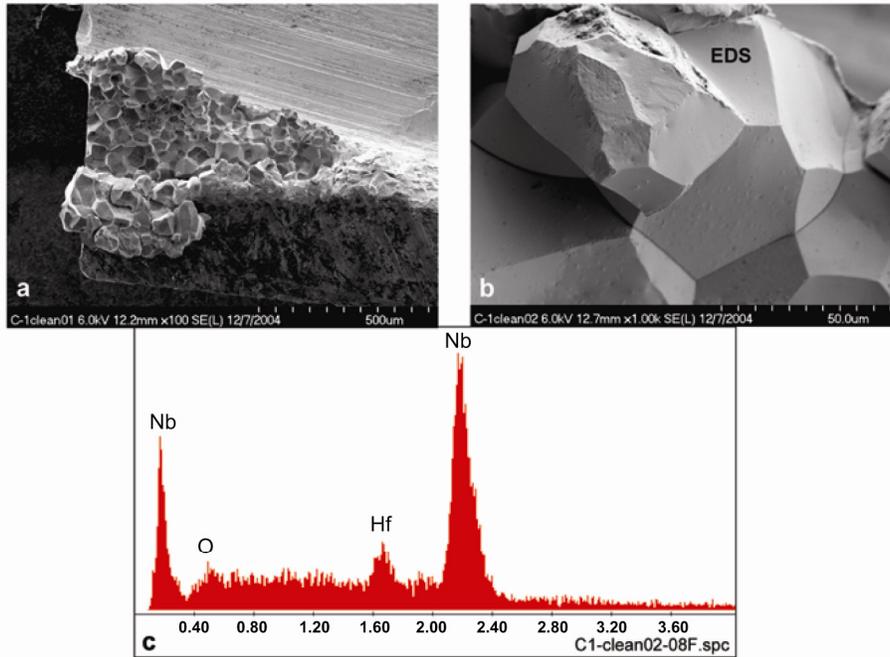
regions of the fracture and were not confined to the crack tips. EDS spectra from the grains without popcorn have reproducibly shown that they are minimally oxidized (fig. 25(c)).

existing intergranular surface from previous laboratory testing on C-103 was selected as a specimen for subsequent oxidation testing, because it was a fracture surface that did not contain the numerous reaction products described in sections 3.1 and 3.2. This specimen, shown previously in figure 25, was from C-ring testing and was only minimally oxidized based on detailed electron microprobe and EDS analyses. This opened intergranular fracture surface was then exposed isothermally in air at 316 °C (600 °F) for durations of up to 100 hr. The 100-hr duration was selected as an upper limit, because thrusters undergo insulation bakeouts at 316 °C (600 °F) for 48 hr in air, and both S/Ns 120 and 132 have each undergone two 48-hr bakeouts in their processing history.

Figure 25.—Opened intergranular crack from 316 °C/207 MPa (600 °F/30 ksi) C-ring test: (a) overall view at low magnification; (b) higher magnification view of crack surface showing the absence of reaction products and Energy Dispersive Spectroscopy (EDS) label indicating grain facet analyzed by EDS; and (c) EDS scan showing low oxygen (O) peak and no fluorine (F) peak. EDS scan is similar to that for baseline C-103 material.

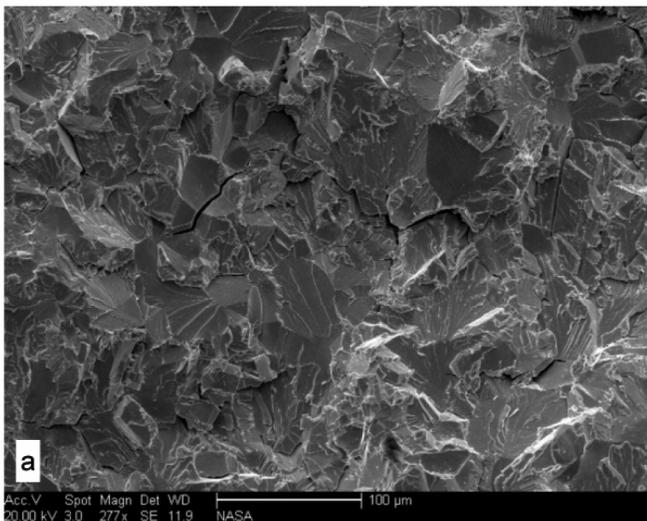
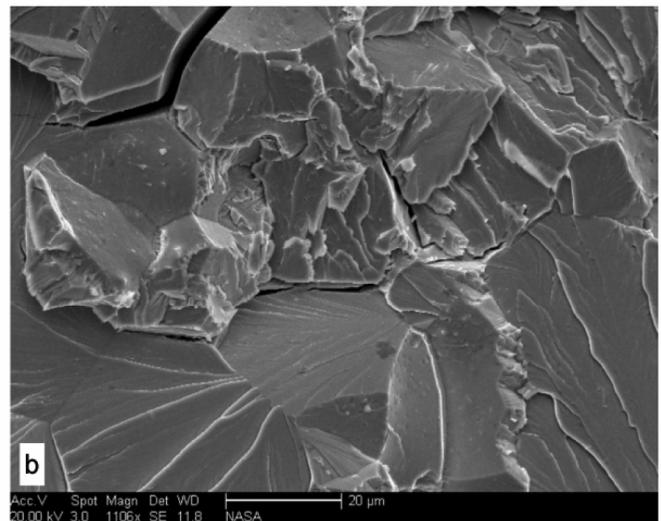
Figure 32.—Fracture surface for a uniaxial tension specimen (specimen 2) exposed to dilute HF solution and loaded to 25.6 ksi at  $-750 \text{ mV}_{\text{SCE}}$ . Specimen failed after 26.5 hr of exposure.

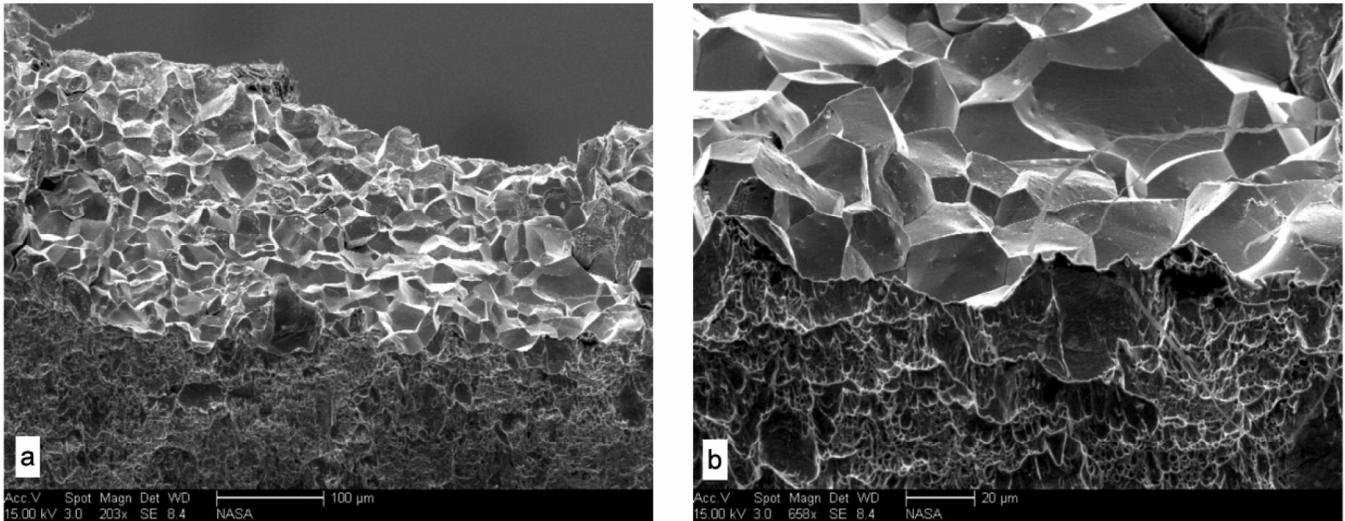
Figure 33.—Fracture surface for a uniaxial tension specimen (specimen 9) exposed to a dilute HF solution without any applied load for 90 hr at  $-1 V_{SCE}$ . Specimen was then baked at  $316^{\circ}C$  ( $600^{\circ}F$ ) for 17 hr under an applied load of 54 kg (120 lb) and then strained to failure. Periphery of fracture surface exhibits intergranular fracture, while majority of fracture surface (internal regions) shows ductile failure.

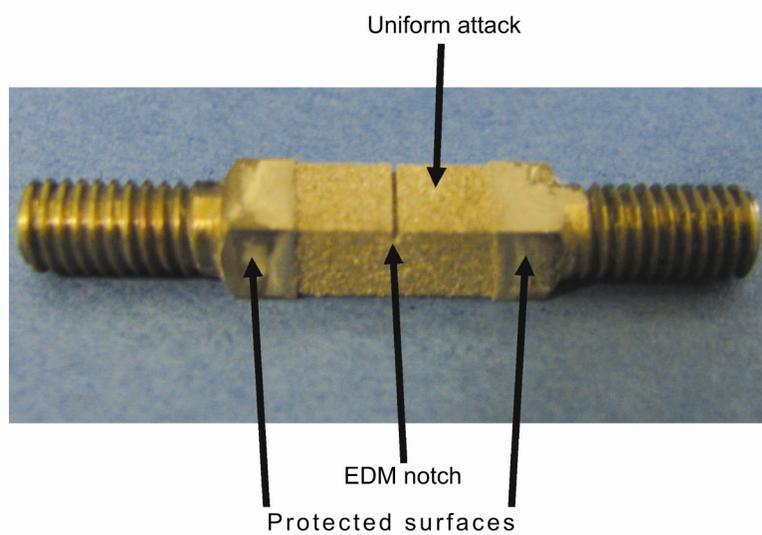
Figure 34.—Uniaxial test specimen (specimen 10) exposed to dilute HF solution and under load at 221 MPa (32 ksi) at  $-100 mV_{SCE}$  for 91.5 hr. Specimen exhibits extensive corrosion, but no cracking was observed.

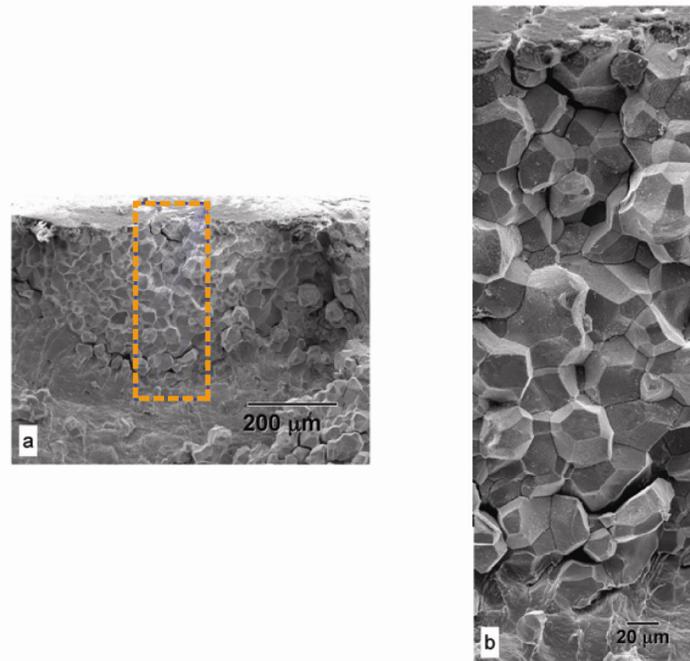
Figure 36.—(a) Overall fracture surface and (b) higher magnification view of a C-103 bend specimen exposed to a dilute niobium etchant solution loaded to 276 MPa (40 ksi) for 36 hr, baked at 316 °C (600 °F) for 48 hr, and exposed to >70% relative humidity for 7 days at room temperature. The applied bending load of 276 MPa (40 ksi) was maintained during bakeout and during subsequent 7-day exposure.

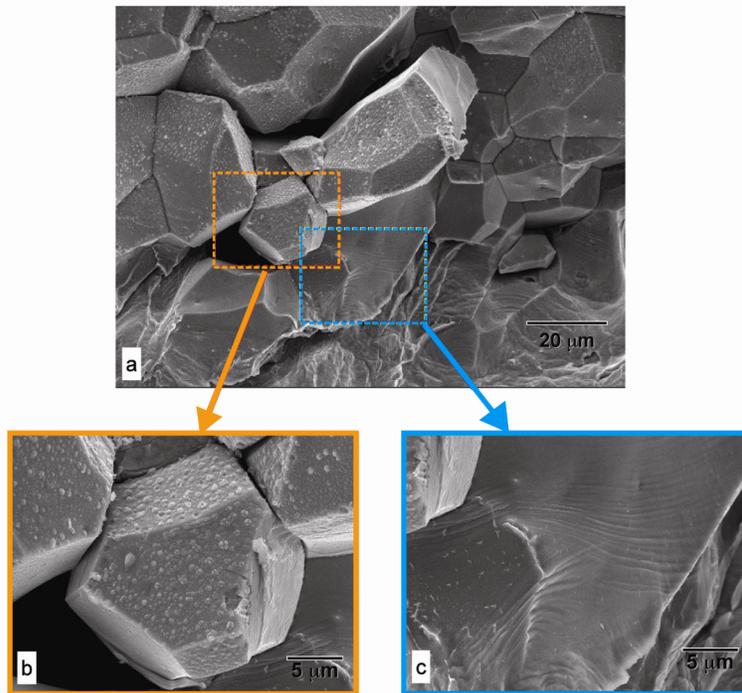
Figure 37.—Base of fracture surface for a C-103 bend specimen exposed to dilute niobium etchant solution loaded to 276 MPa (40 ksi) for 36 hr, baked at 316 °C (600 °F) for 48 hr, and exposed to >70 percent relative humidity for 7 days at room temperature. The applied bending load of 276 MPa (40 ksi) was maintained during bakeout and during subsequent 7-day exposure.

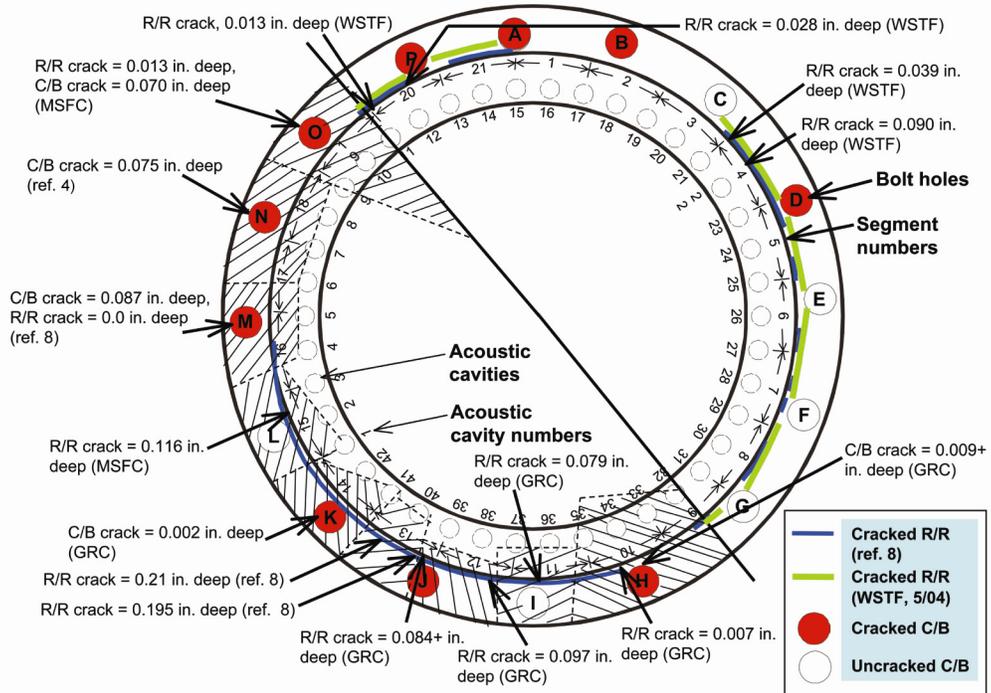
Figure 38.—Schematic diagram of S/N 120 showing approximate locations of examined sections (crosshatched) with measured depths of relief radius (R/R) and counter bore (C/B) cracking indicated. Dye penetrant indications are illustrated by the blue and green lines for R/R cracking and by the red circles for C/B cracking.

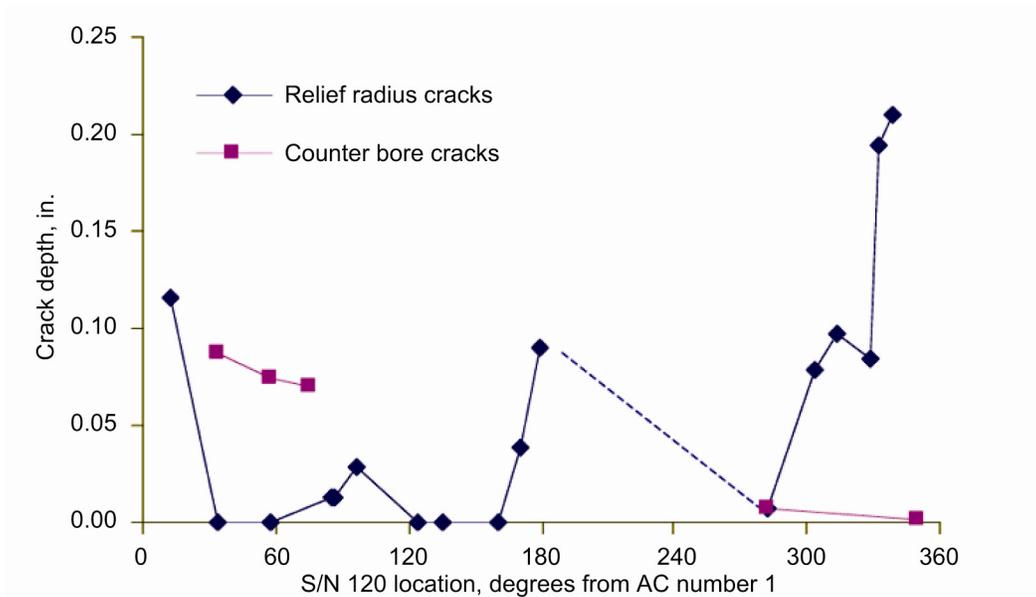
Figure 39.—Depth of cracking in relief radius and counter bores is measured as a function of location in serial number (S/N) 120. Location is given as the number of degrees from acoustic cavity (AC) number 1 shown in figure 38.

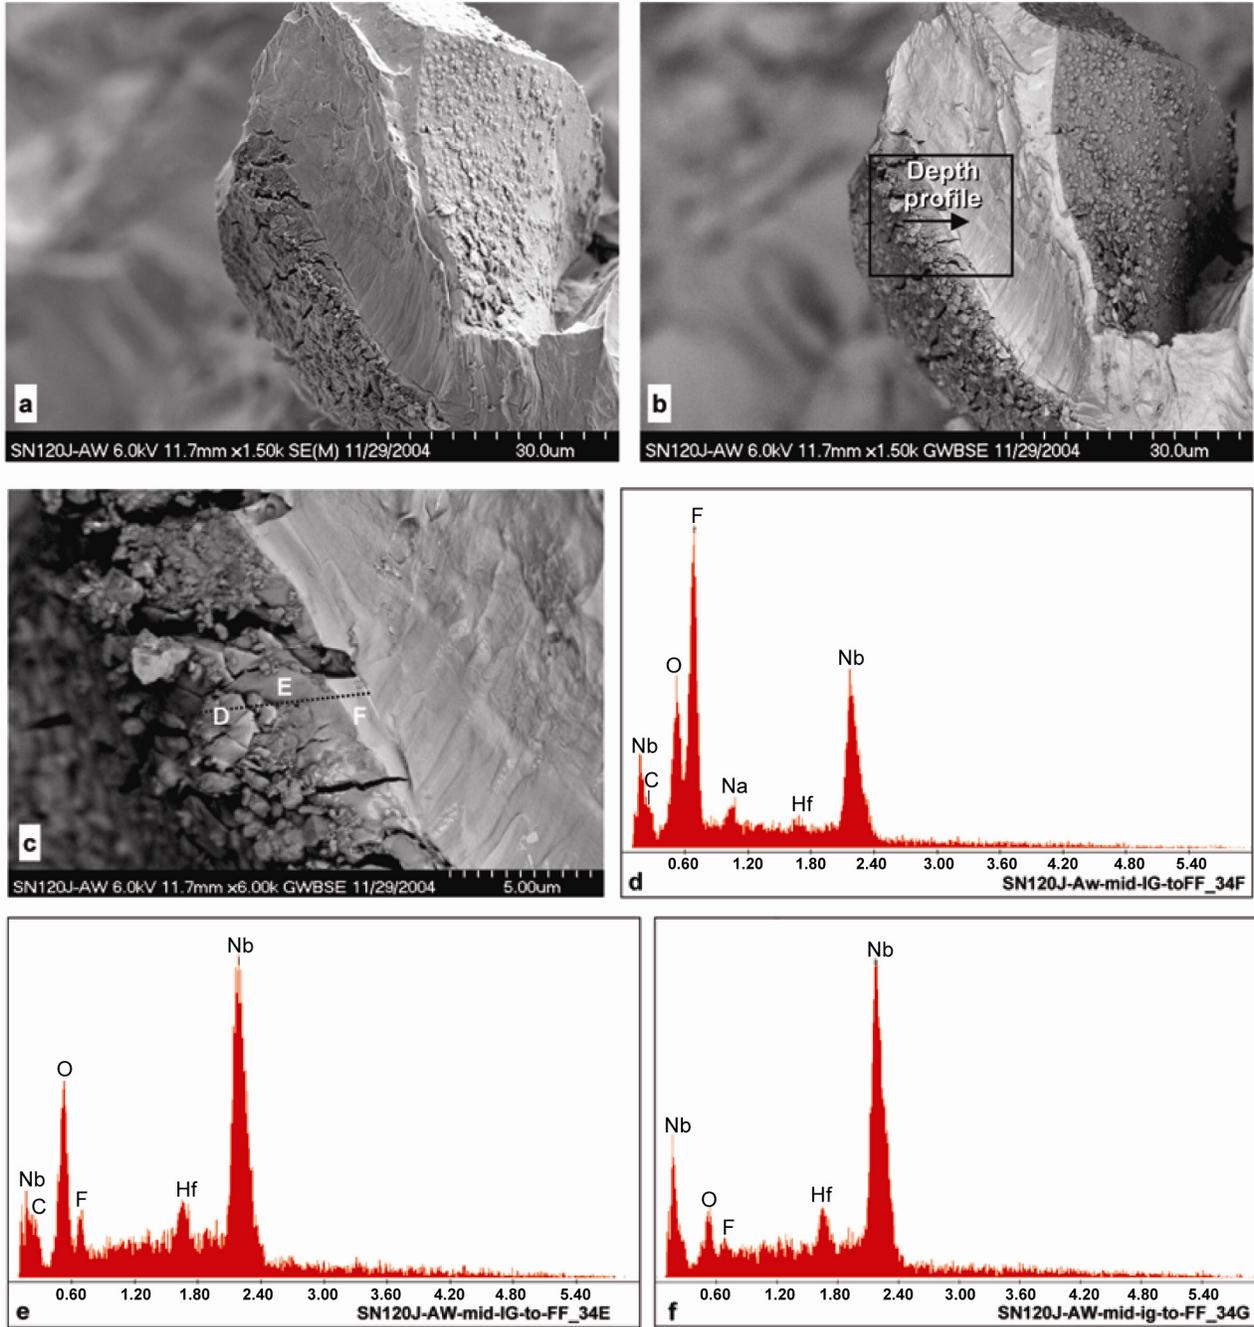
Figure 46.—Grain on S/N 120 fracture surface used for depth profiling through the oxide scale from the top of the intergranular surface down to the newly exposed C–103. The grain boundaries around this grain were cracked nearly all the way around, except for one remaining ligament, which kept the grain attached to the opened fracture surface. (a) Secondary electron image showing topography of uniquely positioned grain. (b) Backscattered electron (BSE) image showing topography and atomic number differences between various features. Here the freshly exposed C–103 is lighter in color than the oxidized scale on the intergranular surface. (c) Higher magnification BSE image of oxide scale with locations D, E, and F shown for Energy Dispersive Spectroscopy scans in (d), (e), and (f), respectively.

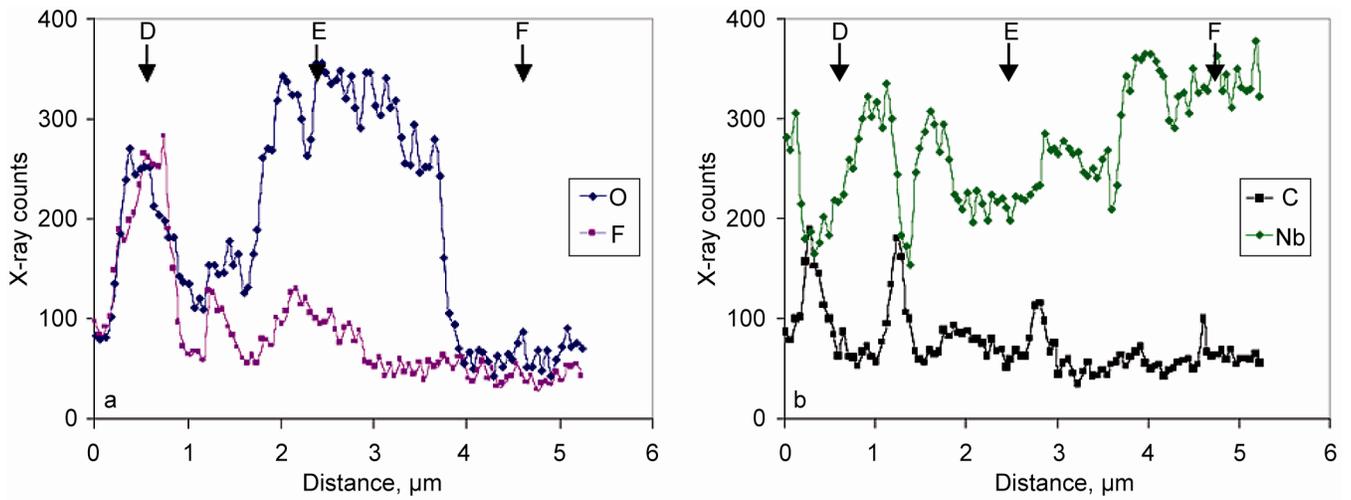
Figure 47.—X-ray line scans showing depth profiling through the oxide scale in figure 46(c). (a) Oxygen and fluorine counts and (b) carbon and niobium counts are shown as a function of distance from the surface inward to the C-103 substrate. The approximate distances for locations D, E, and F from figure 46(c) are also shown for reference.

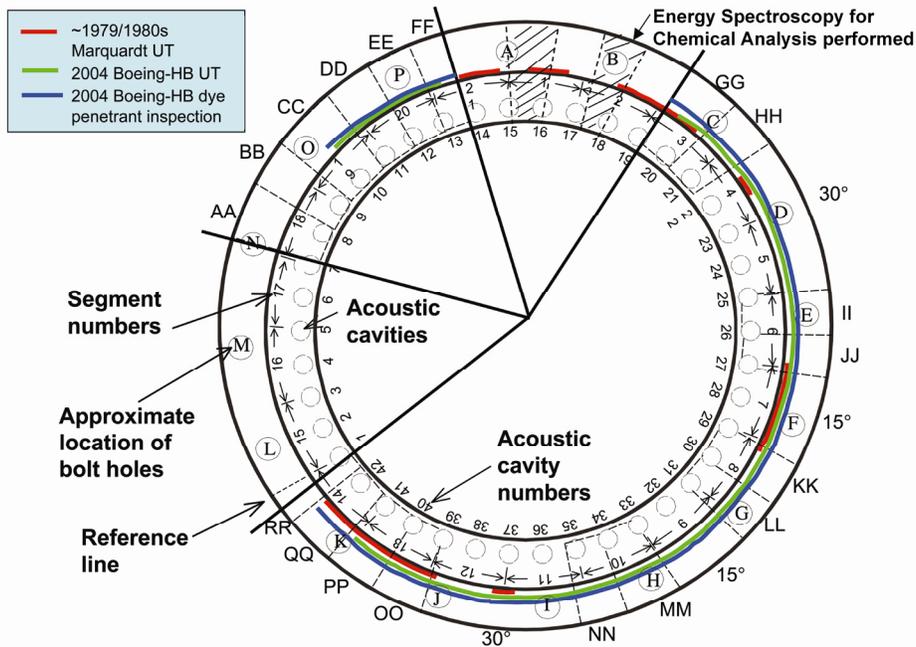
The fracture surface from a relief radius crack near bolt hole B in S/N 132 was also examined by ESCA. This was from a deeper crack than that analyzed in S/N 120, and the location of this cracked section within S/N 132 is illustrated in figure 49. It should be noted that reference 48 incorrectly identified this section as being adjacent to acoustic cavity number 16, when it was actually from the cross-hatched section in figure 49 between acoustic cavity numbers 17 and 18. The fracture surface analyzed from S/N 132 is shown in figure 76, and the specific areas that were analyzed by ESCA are indicated in the figure at locations A to G. The fracture surface is entirely intergranular, and no lab overload region is present in figure 76. Although the entire fracture surface examined in

Figure 49.—Schematic diagram of S/N 132. Sections AA through RR were destructively examined by the SPRT, and two small pie-shaped pieces were examined by Boeing HB (corrected locations are indicated by cross hatching). Ultrasonic (UT) indications are shown by the red and green lines from two separate inspections, and dye penetrant indications are given by the blue lines. Two 15° and two 30° sections were left intact with the injector face for future development of nondestructive evaluation methods.

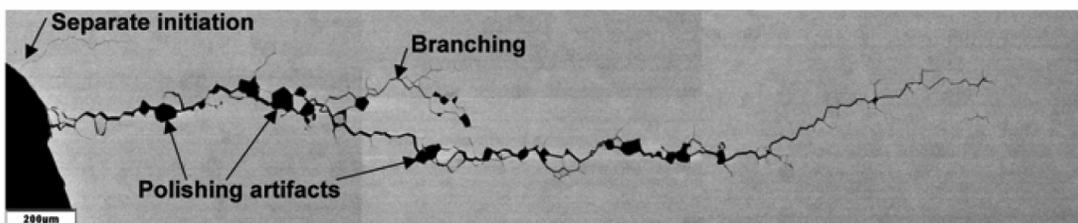
Figure 56.—Cracks were intergranular and no change in crack mode was apparent in the polished sections. Examples of separate crack initiations were observed, in addition to crack branching, in section EE. Polishing artifacts are present from grain pullout during metallographic preparation.

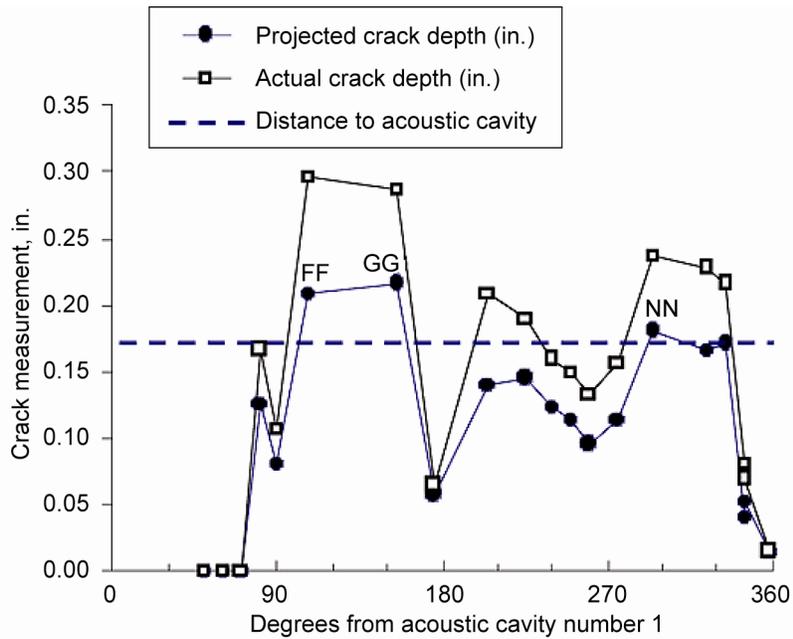
Figure 58.—Crack profile for polished cross sections from S/N 132. The crack front in sections FF, GG, and NN tunneled between two neighboring acoustic cavities, and thus had projected crack depths greater than the distance to the acoustic cavities.

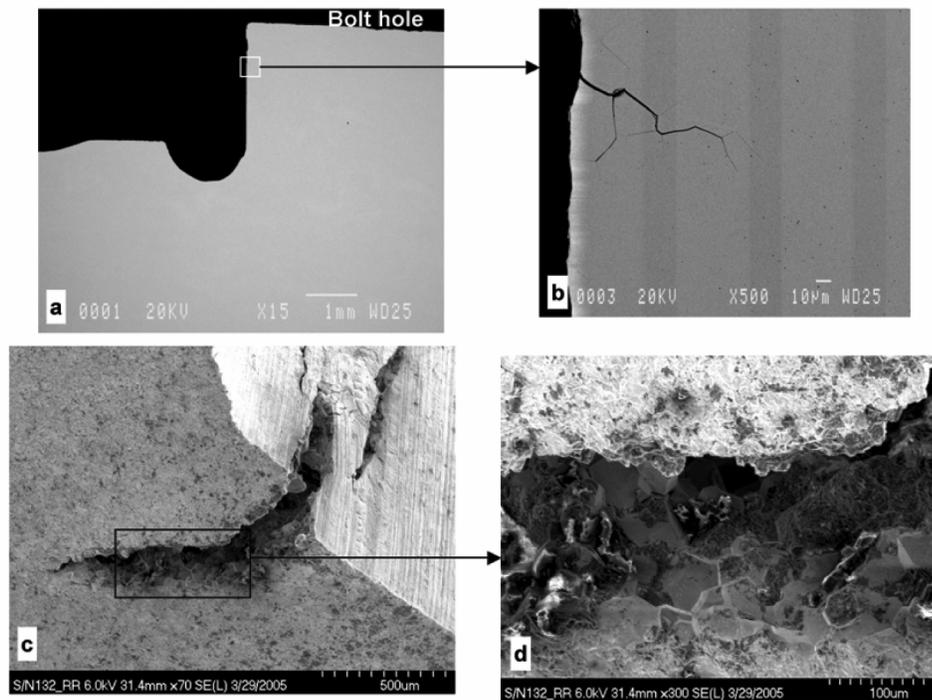
Figure 61.—Shallow intergranular cracks were occasionally observed in S/N 132 on the injector flange well outside of the relief radius region: (a) and (b) section AA after polishing; and (c) and (d) section RR after attempt to open the relief radius crack. In both cases, the intergranular cracking on the flange was only a few grains deep.

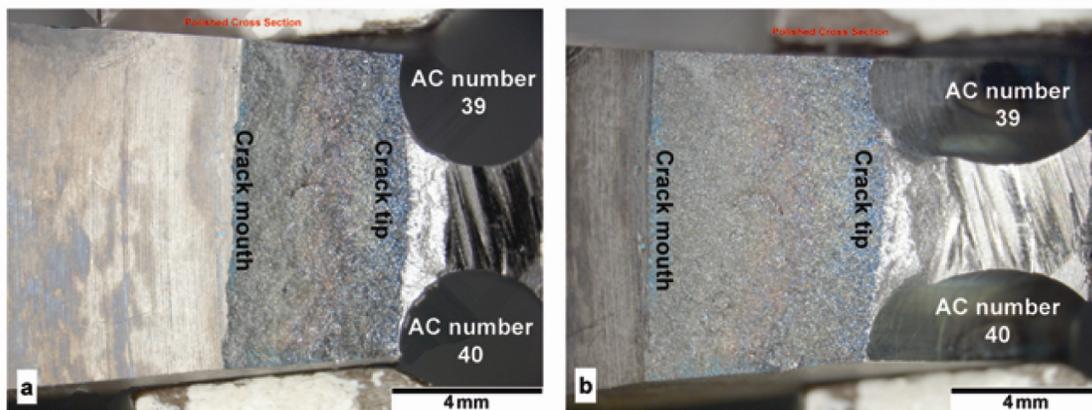
After crack openings were performed, it was found that relief radius cracks penetrated four acoustic cavities: AC numbers 19 and 20 (both in section GG), AC number 35 (section NN), and AC number 39 (section OO). An example of this is seen in figure 62(a), where the crack front is seen to extend into AC number 39; the crack tip fell just short of AC number 40. The micrograph in figure 62(b) also illustrates how the crack tunneled between two neighboring acoustic cavities; a more pronounced example of this is depicted in figure 63, where the crack front is clearly at a maximum depth between the acoustic cavities. This crack in section FF never penetrated either acoustic cavity. The examination of cracks of various depths suggests that the crack in this region was initially uniform in depth. As the crack front approached the acoustic cavities, the crack tip driving force in the region of the acoustic cavities became reduced relative to the crack tip region between the acoustic cavities, which resulted in the development of a tunneled crack front. The most likely cause for the tunneled crack front is the introduction of compressive residual stresses about the acoustic cavities due to the machining operation. It should be noted that no residual stress measurements were made and that the proposal of residual stresses in the region of the acoustic cavities is based solely on the observation of the shape of the crack front from the examination of S/N 132.

Figure 62.—Crack front in section OO extended into acoustic cavity (AC) number 39 in S/N 132, but was just short of penetrating into AC number 40. (a) Viewing axis is parallel to the AC wall. (b) Viewing axis is perpendicular to the crack face. Crack tip is seen beginning to tunnel between ACs.

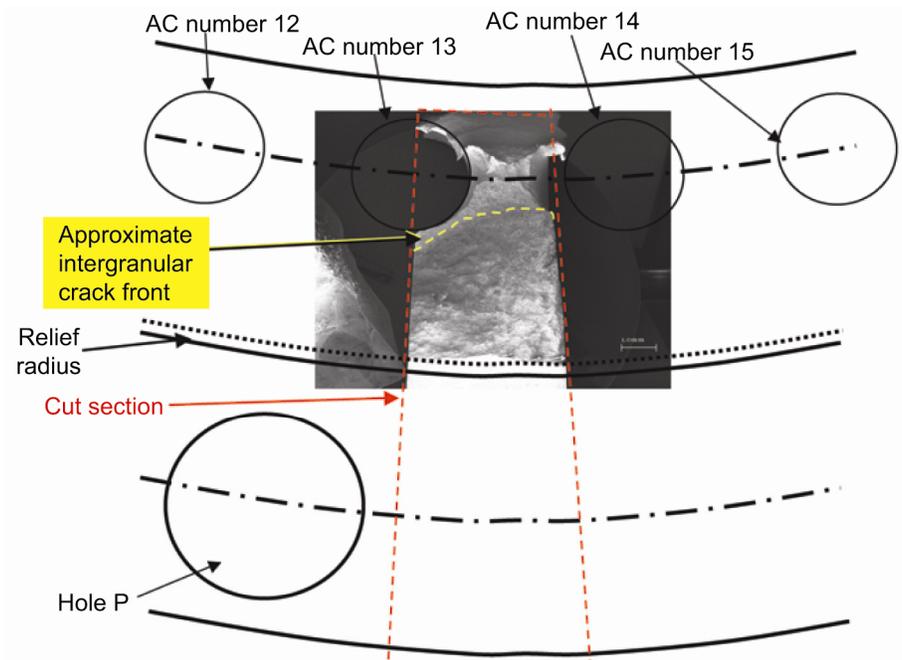
Figure 63.—Schematic of injector with superimposed photomicrograph showing the intergranular crack front in section FF of S/N 132. Crack front tunneled between neighboring acoustic cavities but did not penetrate either acoustic cavity. This clearly illustrates how the maximum crack depth can be greater than the distance from the relief radius to the acoustic cavity.

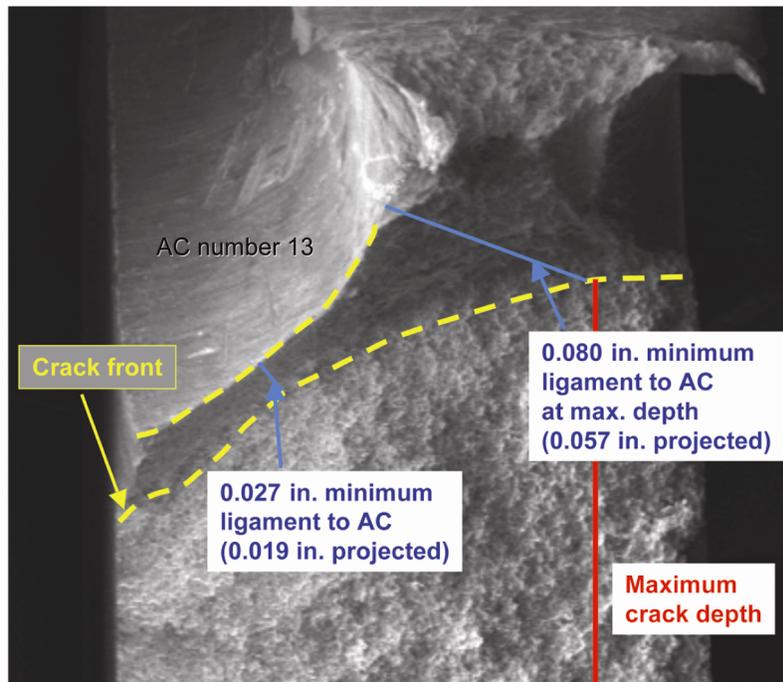
cavity; figure 64 illustrates that these minimum ligament distances were usually not the same. Table VI summarizes the measurements that were taken from the opened crack surfaces of S/N 132. The table identifies each section by letter and its location on the circumference of the relief radius, based on the number of degrees clockwise from AC number 1. Again, there is an absence of data between 0 and 50° and between 107° and 155°, because those parts of the injector were not available for analysis.

Figure 64.—Minimum ligament distances are determined on the fracture surface of section FF in S/N 132. The minimum ligament distance to the acoustic cavity (AC) is compared to the minimum ligament distance to the AC at the maximum crack depth.

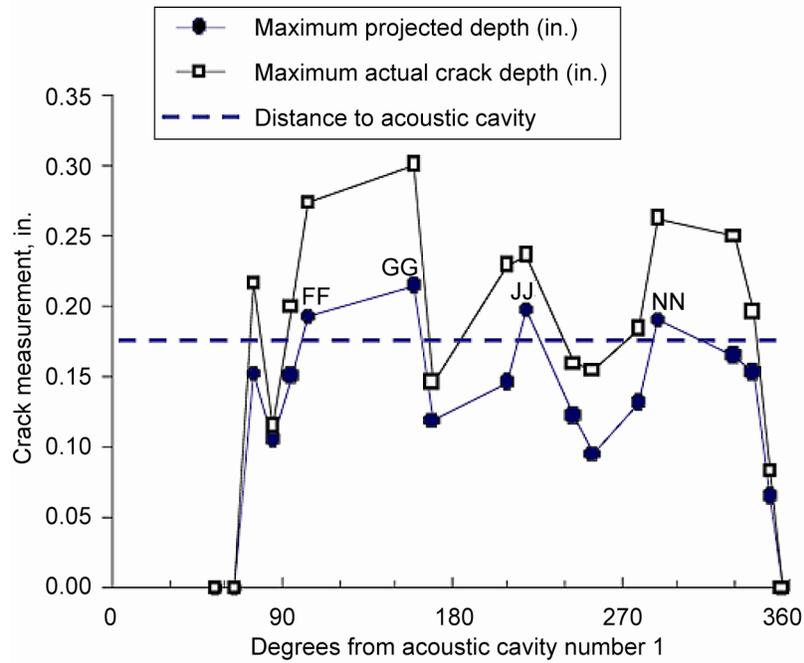
Figure 65.—Crack profile for opened crack faces from S/N 132. The crack front in sections FF, GG, JJ, and NN tunneled between two neighboring acoustic cavities, and thus had projected crack depths greater than the distance to the acoustic cavities.

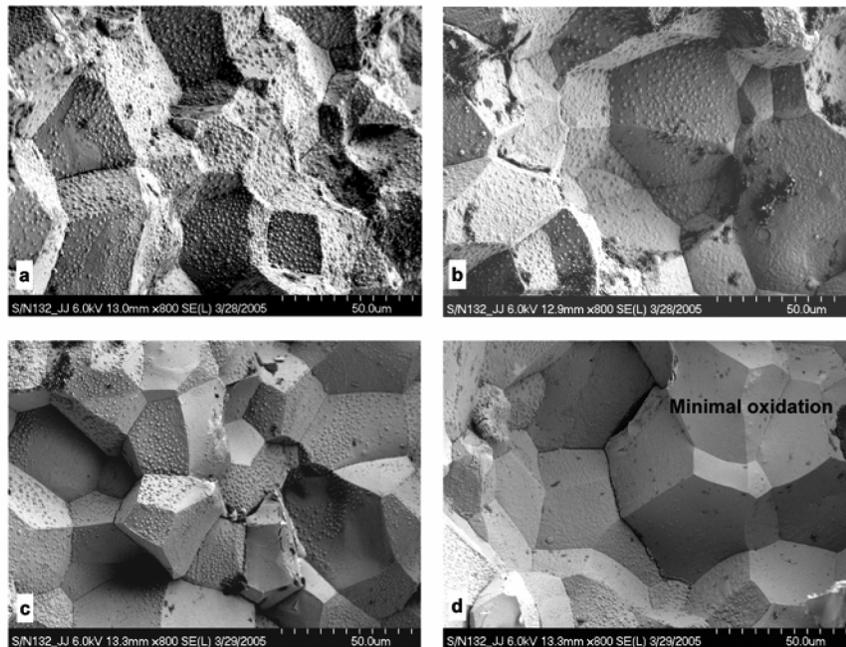
The fracture surfaces in S/N 132 were also examined carefully for any evidence of crack growth. Popcorn oxidation was observed along the crack front from the crack mouth to the crack tip, as seen in figures 66(a) to (c). No significant changes in the popcorn appearance were observed across the crack surface. However, regions of clean-looking grains with no popcorn were observed at the crack tip next to grains that were covered with popcorn, and an example of this is shown in figure 66(d). This clean appearance of some of the grains at the crack tip has been reported previously for S/N 132 in reference 48. Intergranular crack surfaces with no popcorn or other reaction products have also been produced by monotonic laboratory testing; this was shown previously in the C-ring specimen in figure 25(b) and in the uniaxial tensile specimen in figure 33. In contrast to S/N 132, the clean grains in the laboratory-tested specimens were observed across wide

Figure 66.—Popcorn oxidation was typically observed across the entire fracture surface of S/N 132; the fracture surface of section JJ is shown. (a) Crack mouth. (b) Mid-depth of crack. (c) Popcorn at the crack tip. (d) “Clean” grains also observed at the crack tip.

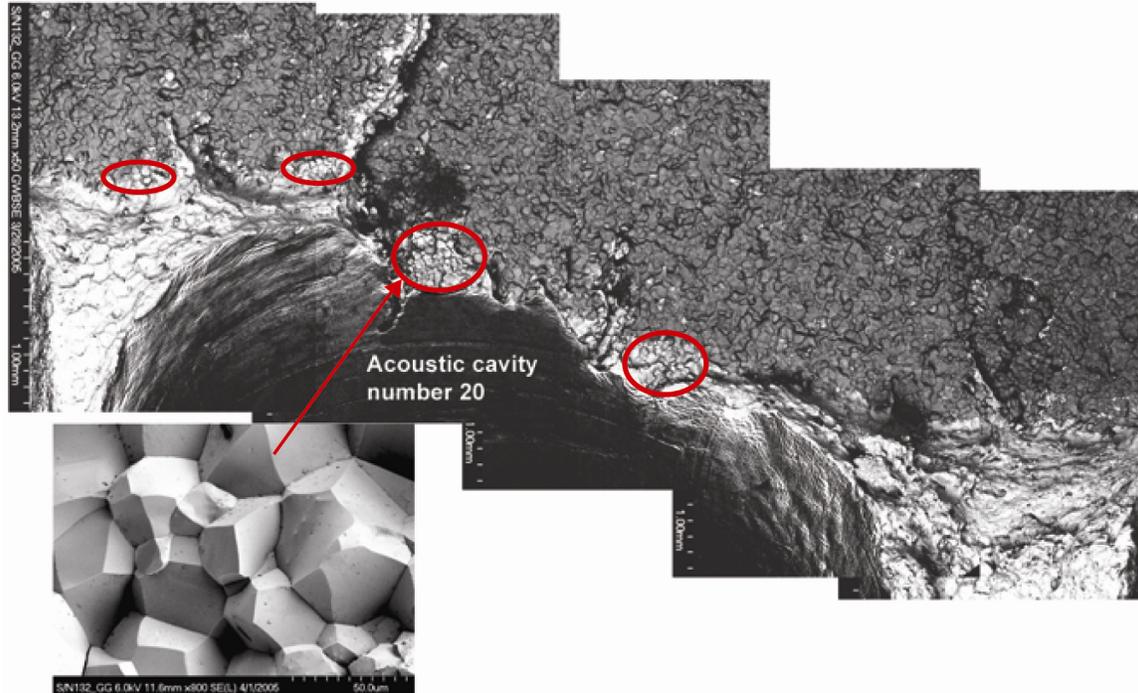
The three possible explanations given above for the observation of minimally oxidized grains at the crack tip in S/N 132 cannot be ruled out. If the clean grains are interpreted as evidence for crack growth following manufacturing, the amount of crack growth would be extremely limited. Therefore, it has been concluded that no evidence was found in S/N 132 for *appreciable* crack propagation after manufacturing, with *appreciable* being defined as greater than 0.08 mm (0.003 in.). The lack of widely distributed clean grains at the crack tip is demonstrated in figure 67. This figure is a montage of BSE micrographs showing a typical distribution of minimally

Figure 67.—Minimally oxidized grains, which showed no popcorn oxidation, were located in discrete pockets along the crack front. Typical distribution of these “clean” grains at the crack tip is indicated by the red ovals. Section GG of S/N 132 is shown here.

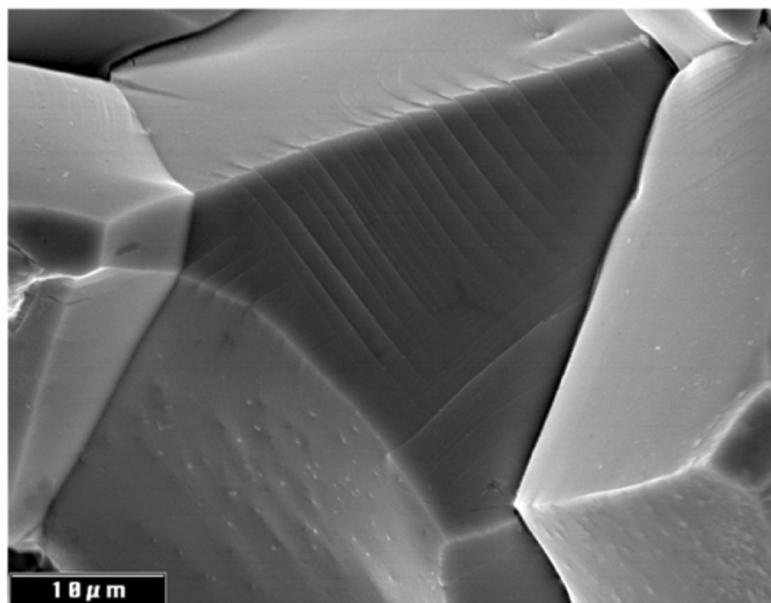
A few other features were noted on the fracture surfaces of S/N 132. Figure 68 shows what appears to be slip planes on some of the minimally oxidized grain facets at the crack tip. This may provide evidence for a hydrogen embrittlement mechanism, which involves sweeping hydrogen into the plastic zone through dislocation transport from the crack tip. Hydrogen becomes trapped on the dislocations at the crack tip and preferential slip occurs locally. The uptake of hydrogen at the crack tip by this mechanism has produced intergranular fracture modes in the literature (refs. 52 and 53). Other regions of the oxidized fracture surface show what appear to be striated patterns of deposits on the grain facets (fig. 69). This has been observed previously in S/N 132 (ref. 48) and in counter bore cracks of S/N 120 (ref. 54). The reason for this striated pattern is unknown at this time; it is possible that this feature may be the result of popcorn formation along the slip planes observed in figure 68.

Figure 68.—Slip planes were observed on clean grain facets at the opened crack tip of section LL in S/N 132. This observation is consistent with a hydrogen embrittlement mechanism that involves slip localization due to the trapping of hydrogen at the crack tip.

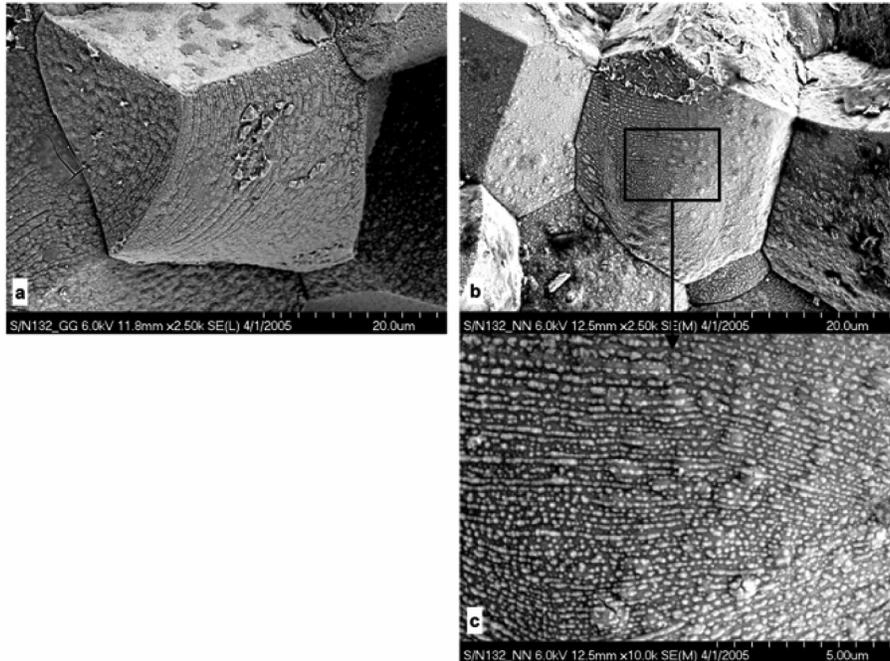
Figure 69.—Intergranular fracture surfaces of S/N 132 also contained areas where deposits had a striated appearance. This was also observed in S/N 120.

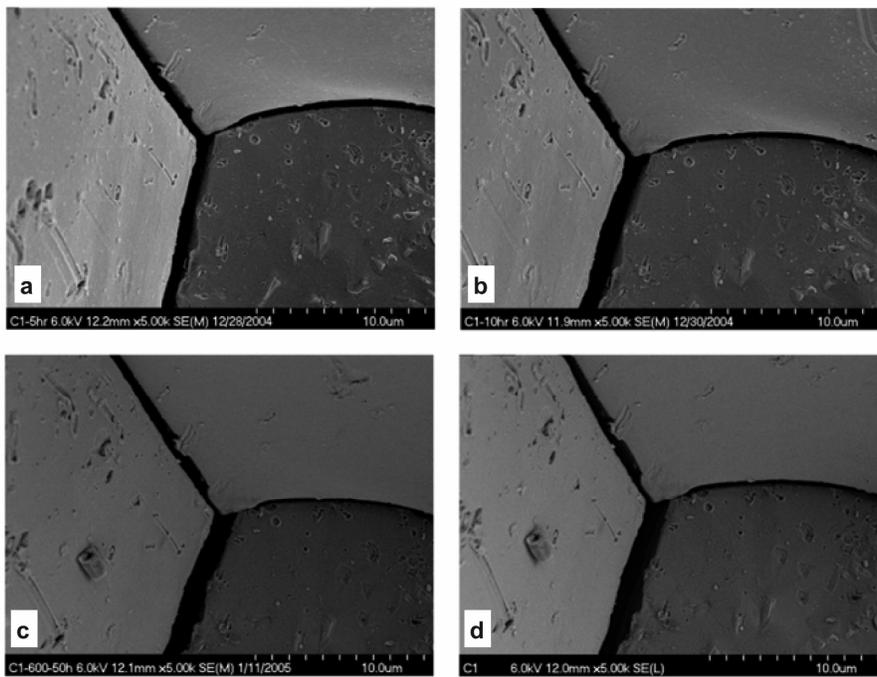
SEM and EDS were performed after each oxidation exposure of 5, 10, 20, 30, 50, and 100 hr at 316 °C (600 °F) to monitor the intergranular surface for possible changes in surface features and chemistry. After each oxidation interval, numerous grain facets on the fracture surface were examined for possible popcorn formation, since grain orientation has been shown to influence subsequent oxidation (ref. 44). Figure 70 shows the same set of grains at a triple point as a function of exposure time at 600 °F. It is evident in the figure that no popcorn or cuboidal oxide formation was observed even after 100 hr at 316 °C (600 °F), which is roughly equivalent to the exposure conditions from two thruster bakeout cycles. Figure 71(a) shows the EDS scan for the starting fracture surface, which is representative of minimally oxidized C-103 material. EDS scans obtained after 10, 50, and 100 hr at 316 °C (600 °F) are displayed in figures 71(b) to (d), respectively, and show that the biggest change in the fracture surface chemistry is observed after 10 hr, where the oxygen peak increased significantly in magnitude. Thus, the sample was oxidizing during the 316 °C (600 °F) exposures, but no other significant changes were evident. The results show that exposure times and temperatures consistent with a double bakeout cycle enable an oxide scale to form on C-103 but are insufficient for popcorn formation. It should be pointed out that the thruster is exposed to the out-gassing of water and carbon dioxide (ref. 55) from the thruster insulation material during the manufacturing bakeout, and this was not being simulated in these laboratory oxidation tests.

Figure 70.—Grain surfaces at triple point of C-103 fracture surfaces after 316 °C (600 °F) oxidation exposures in air for (a) 5 hr; (b) 10 hr; (c) 50 hr; and (d) 100 hr. No popcorn formation occurred.
